New Low Speed Impact Injury Symptom Threshold Published

New Low Speed Impact Injury Symptom Threshold PUBLISHED

SINTRA
ENGINEERING INC

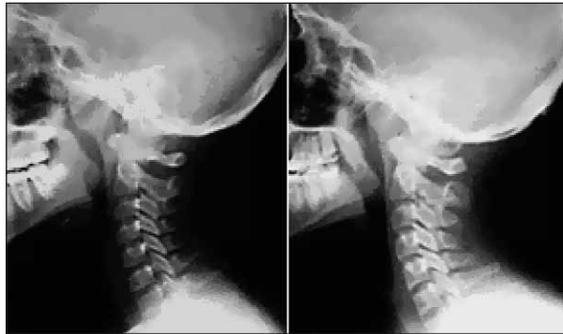
risk curve to the data. The result is a prediction curve for when WAD I and II symptoms of any duration are expected from a particular

THE RESULTING INJURY RISK CURVE DEMONSTRATED A GOOD ABILITY TO PREDICT THE INCIDENCE OF SYMPTOMS OF ANY DURATION

This threshold range is based upon a large sample that includes both human volunteer tests and real world collisions. All of the over 200 subjects represented in the data set were exposed to a single rear impact. The resulting injury risk curve demonstrates a good ability to predict the incidence of symptoms of any duration.

threshold - a change in velocity of 8 km/h - is better represented as a range: from 7.8 to 11.1 km/h with a 95% confidence interval. This means that within this range the likelihood of experiencing

injury symptoms begins to switch from unlikely to likely. The range reflects the variability among individuals.

Furthermore, at changes in velocity lower than 7.8 km/h, symptoms are not expected.
